*Art &
Conservation*

Conservation and Restoration of Fine Art and Architectural Detail

PORTFOLIO

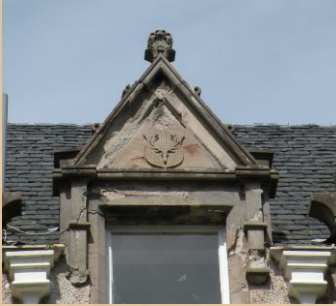
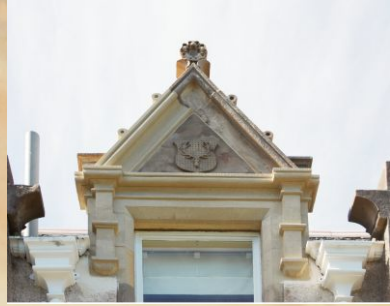
Fig. 1-2.: One of the pediments: pediment with shield and stags head. Before and after conservation. (Stones cut by the stone mason)

Conservation and restoration of 18th century architectural detail of the B listed building. Works included project managing the site and undertake complex restoration and conservation of pediments, stone plaques, gargoyles, finials, capitals and wall memorial. Works included: mortar repairs and reconstructions (lithomix, acrylic mortar based on Paraloid B72), Consolidation with silanes and solutions of Paraloid B72, re-pointing and re-building, removal of ferrous dowels, stone replacement, stone cleaning.

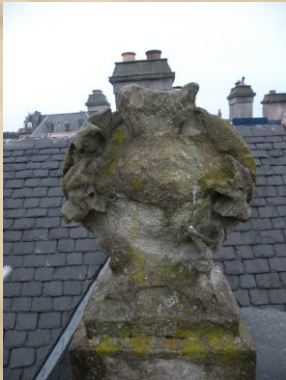
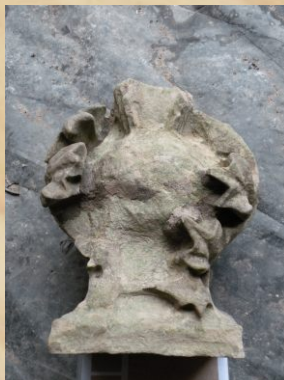
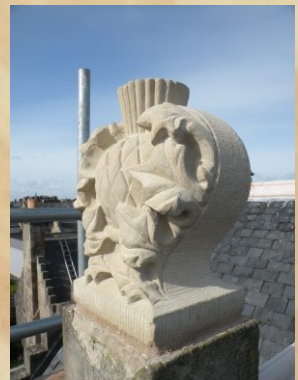
Fig. 5-7.: One of the finials. Because the stone was in such a bad condition it was decided to replace it. However the old stone was conserved and kept as a garden feature. New stone was carved by Karolina Kubisz.

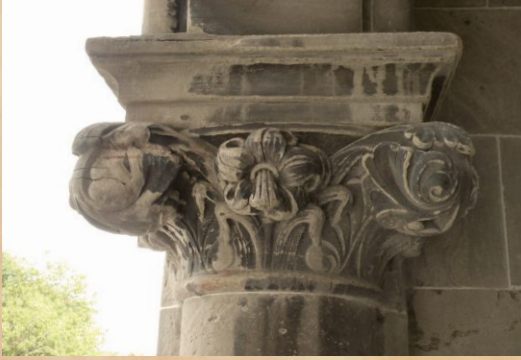
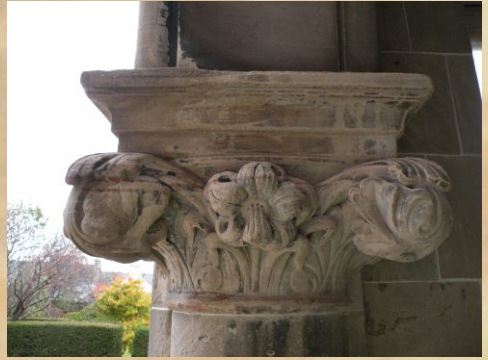
Fig. 8-9.: Capital before and after cleaning and conservation.

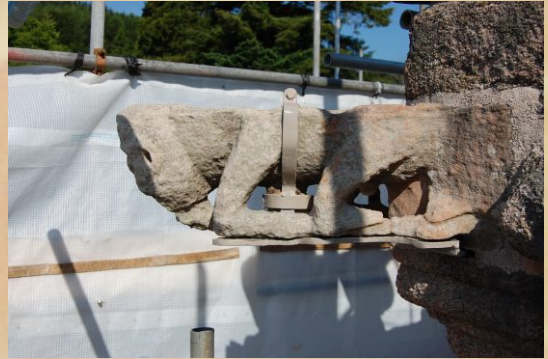
Fig.: 16-17.: Gargoyle before and after cleaning and conservation. Phosphor bronze armatures were applied to support the fragile stone.

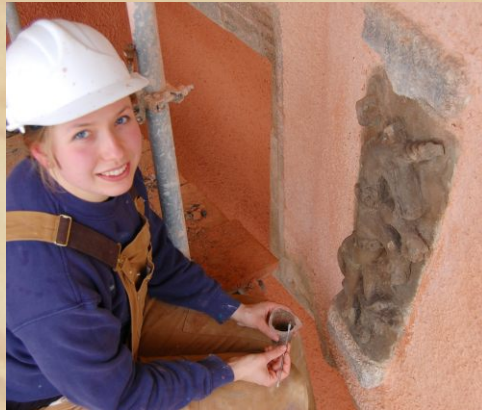
Fig.: 18-20.: Relief carving before and after cleaning and conservation.

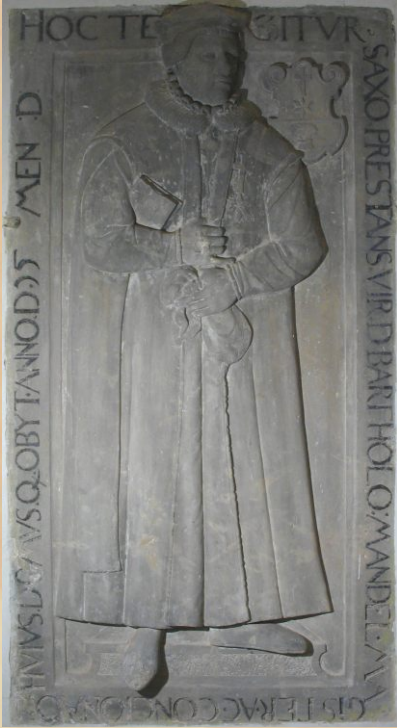
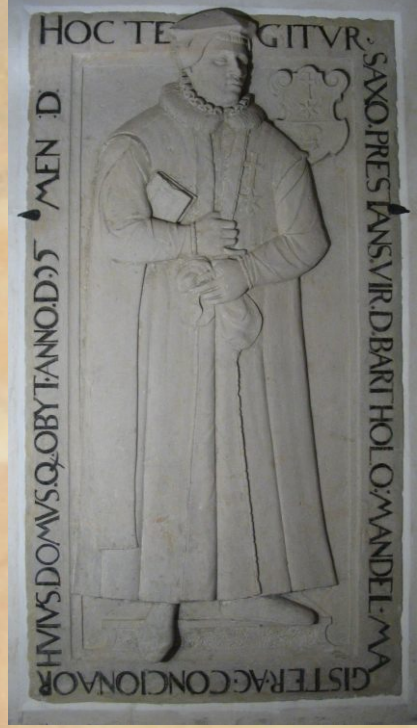
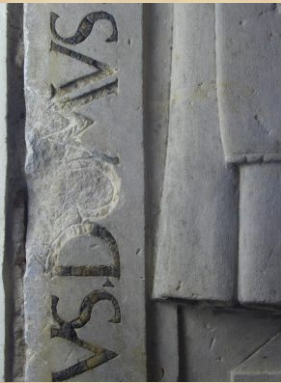
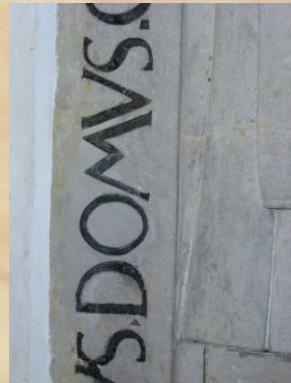
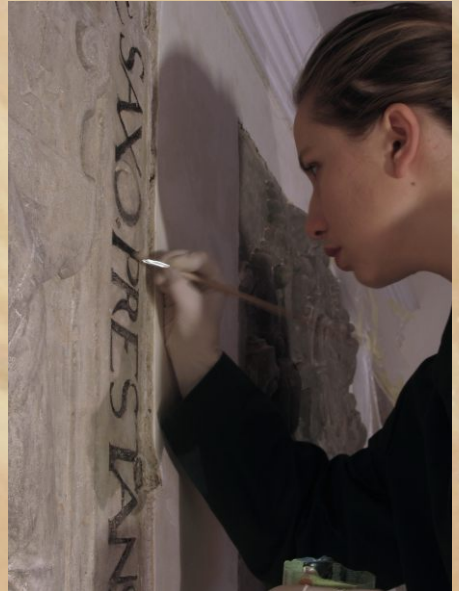
Fig.: 21-25.: Memorial before and after cleaning and conservation.

Works including chemical and steam cleaning, removal of oil paint, consolidation of original and historical polychromy, mortar repairs, consolidation of inscription fill, full documentation.

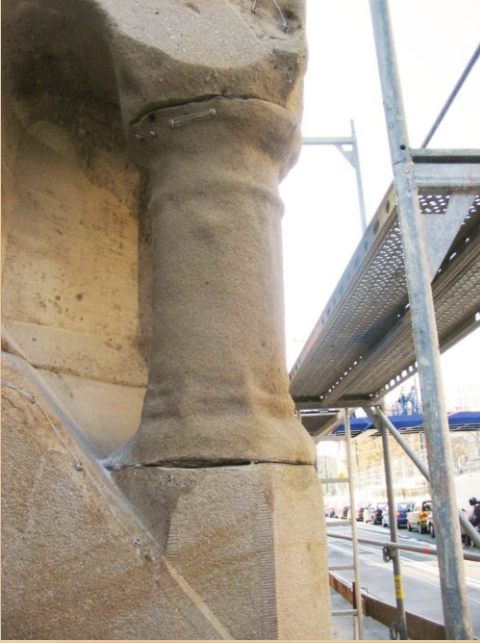
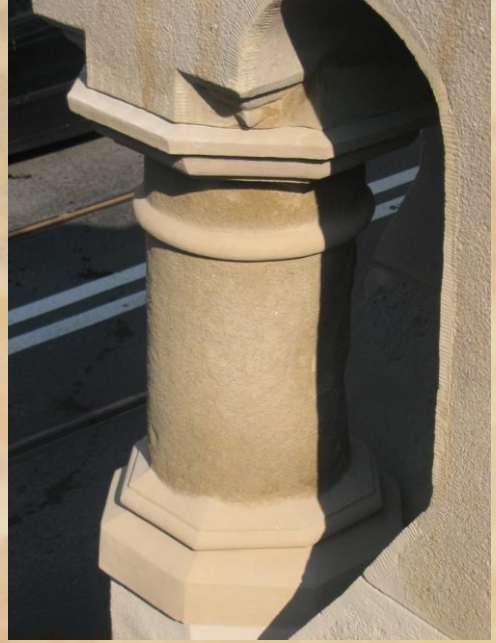
Fig.: 26, 27.: Cracow; Reconstructions made using stainless steel armatures and two ready made mixes by Baunit and Remmers, upper part mixed with Remmers Hafffest for better adhesion.

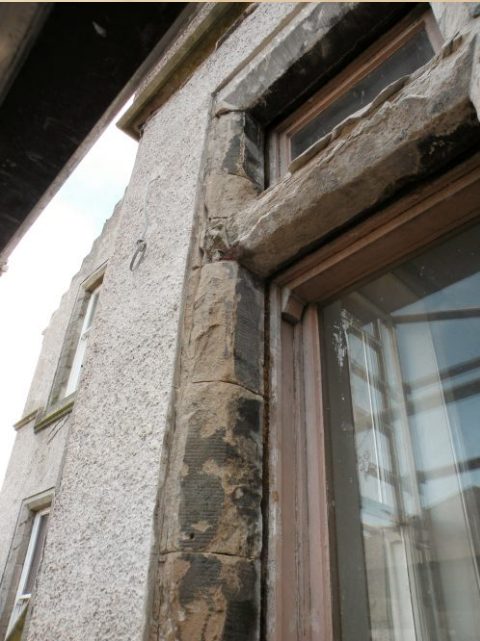
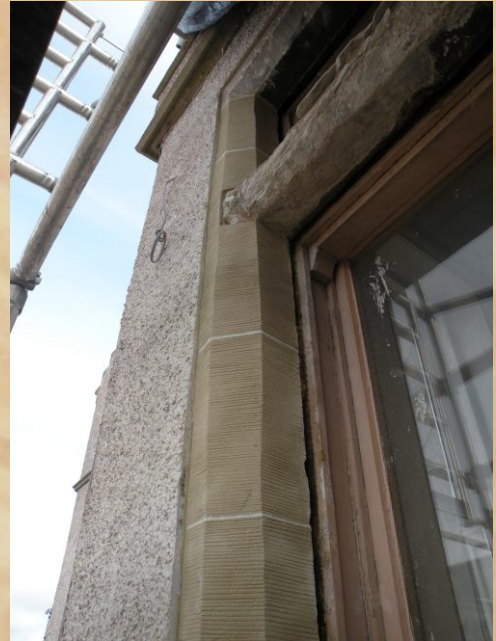
Fig.: 28, 29.: Nairn; Reconstruction based on Lithomix. Repair was matched to the new stones replacing the transoms and mullions.

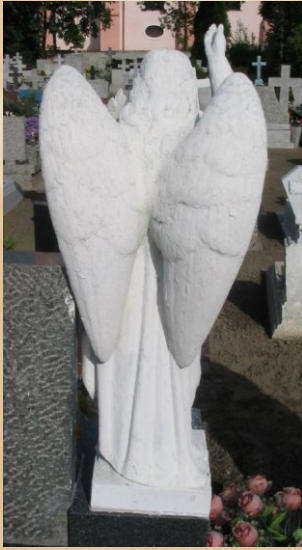
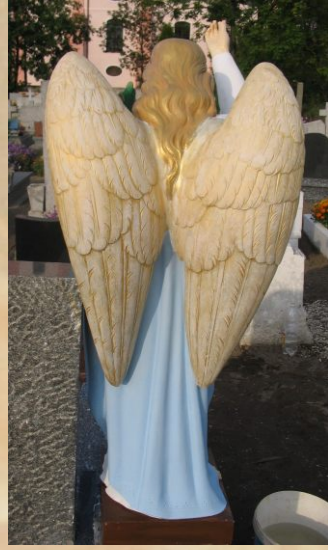
Fig.: 30-31.: Conservation and restoration of ceramic sculpture of an angel. Works included removal of more than 10 layers of oil based paint, reconstruction of fingers, painting the figure with weather resistant water based paint.

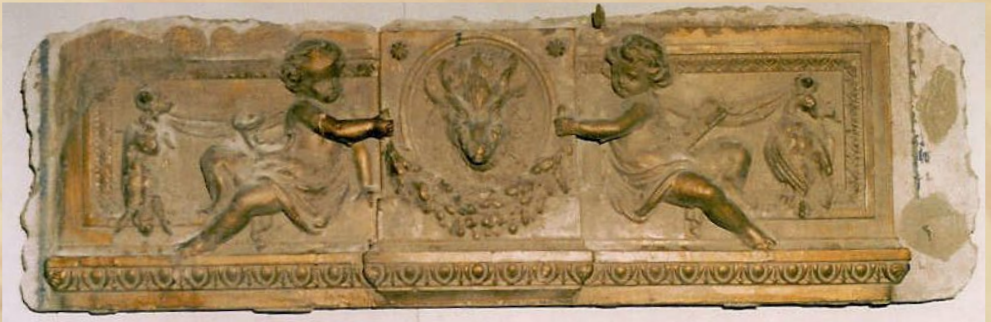
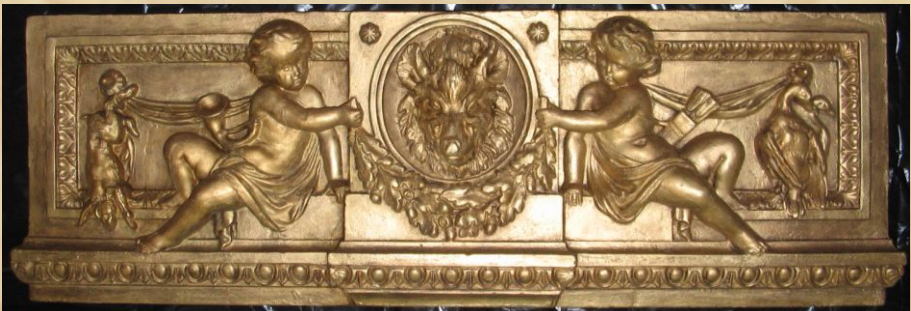
Fig.: 32-33.: Rysiowice Castle. Gilded ceramic tile from fireplace. Works included removal of many layers of paint and cement from the back, gluing the pieces together, reconstructions, gilding.

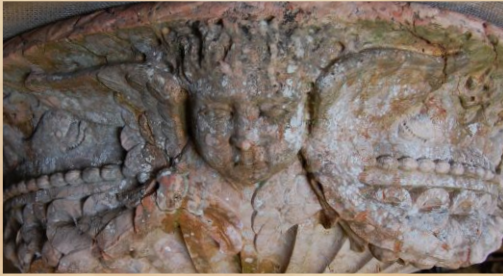
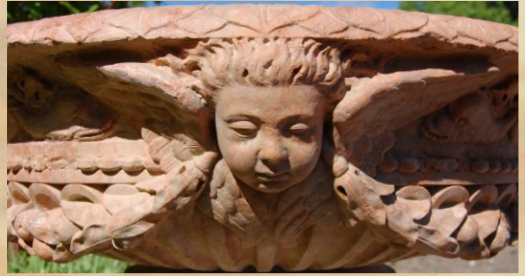
Fig. 34-35.: Conservation of decorative piece of marble.

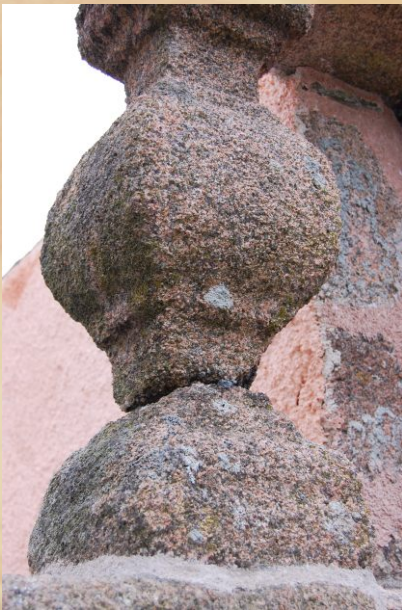
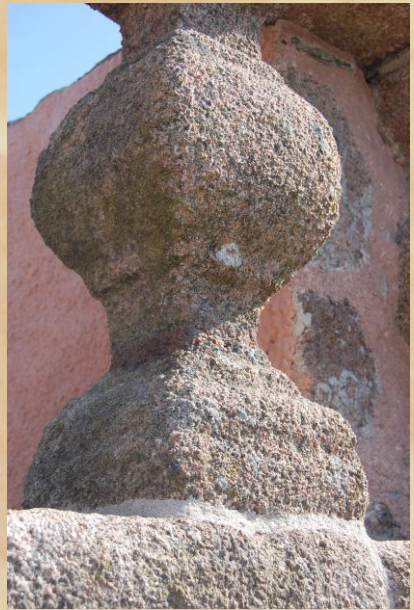
Fig. 36-37.: Example of granite repair.

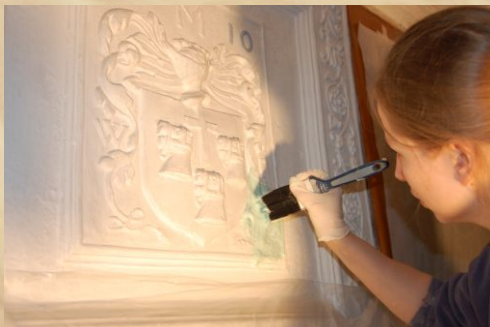
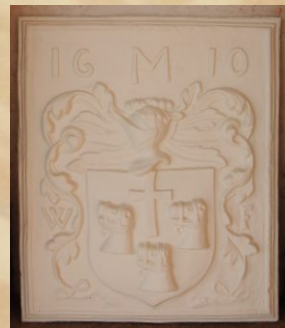
Fig. 38-39.: Making the mould and casting the copy of one of the plaster decorations.

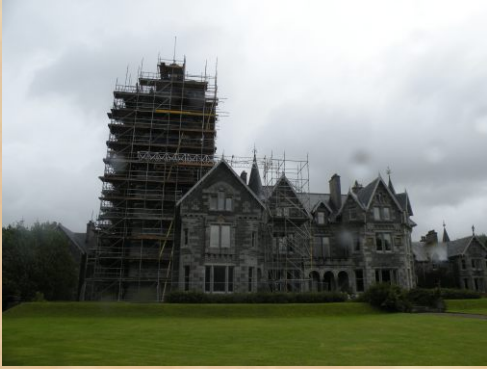
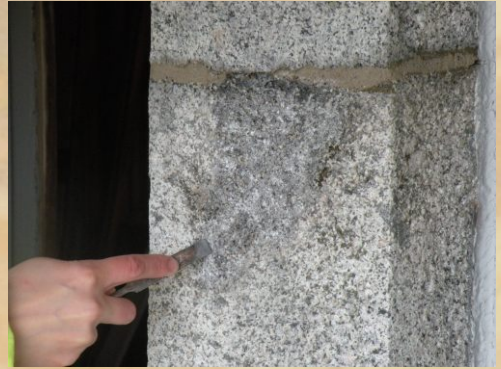
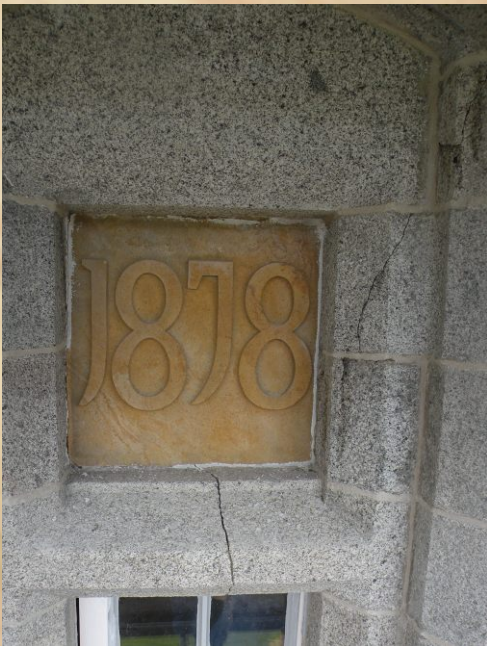
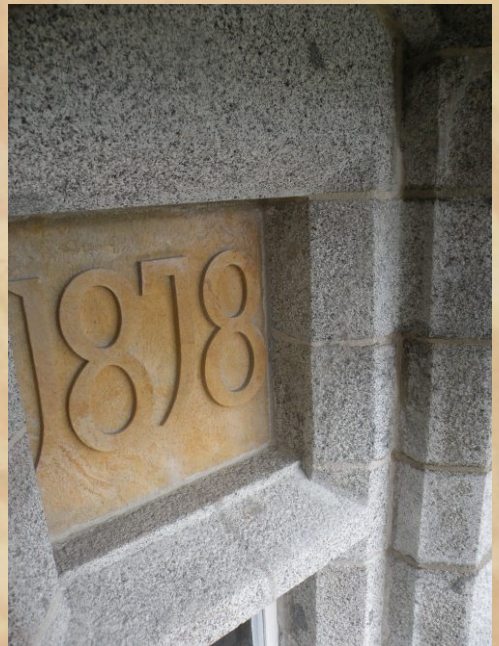
Fig. 41-43. Granite repairs. Works including inserting stainless steel armatures. Resin and lime grout injections. Acrylic and polyester based mortar repairs.

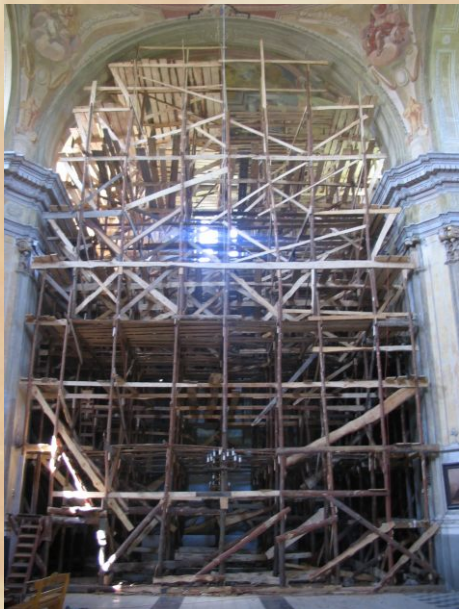
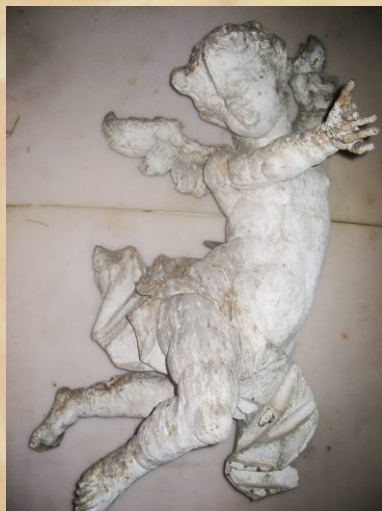
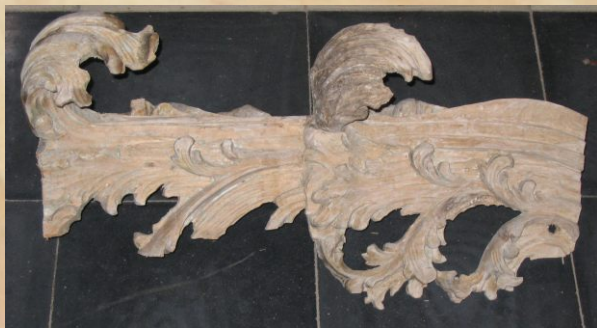
Fig.44-49.: Works included taking part in wood consolidation, wood reconstruction using epoxy base putty, dry cleaning of wooden sculptures, preparation for gilding including removal of old desintegrated gilding and applying many layers of a new base for gilding.

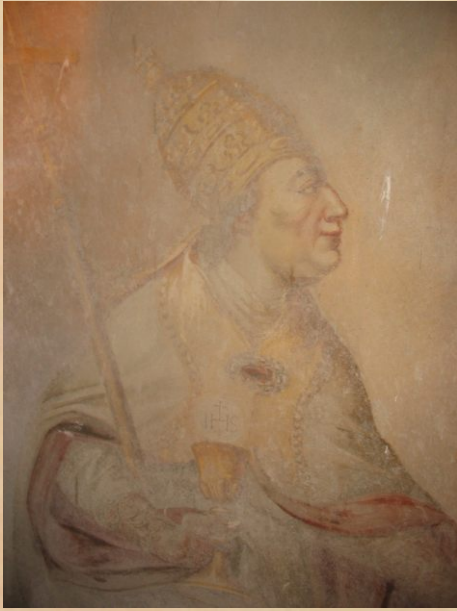
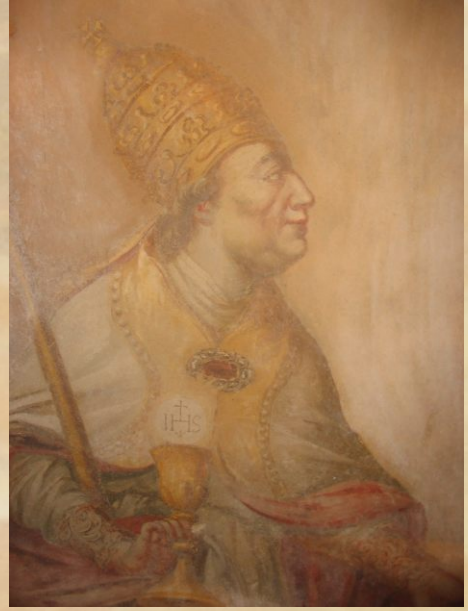
Fig. 50-51.: Taking part in first stage of fresco conservation- cleaning. On the later stage other team of conservators was consolidating and restoring the frescos according to the highest standards.

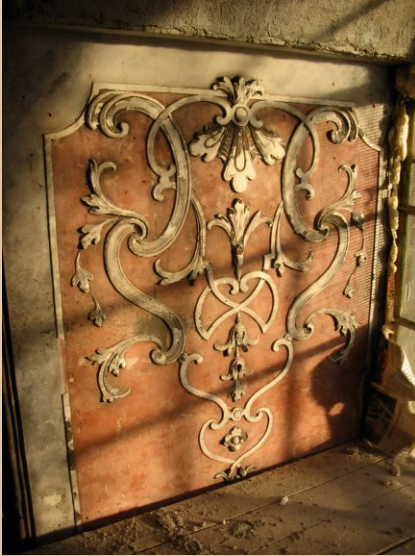
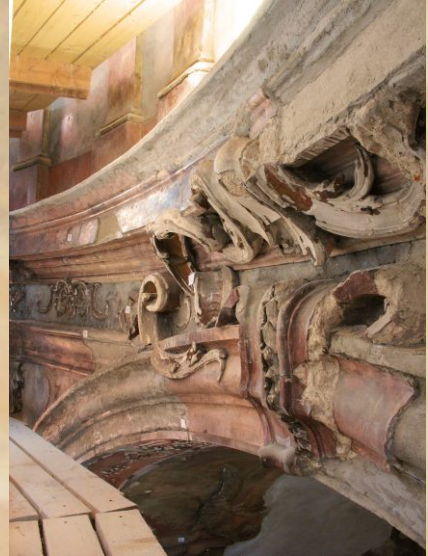
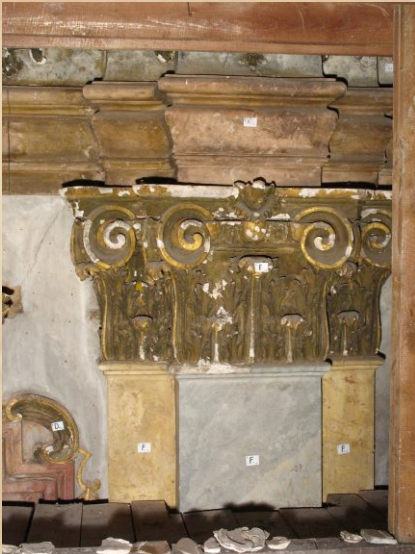
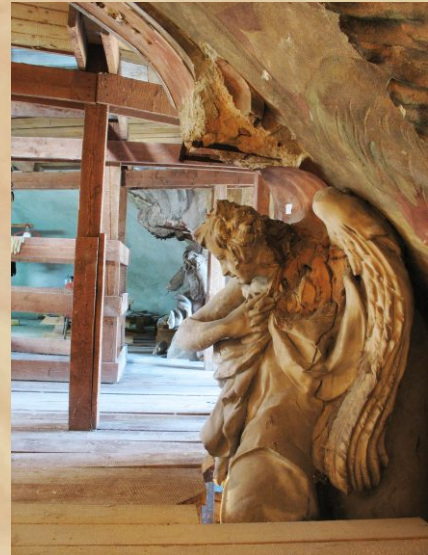
Fig. 55- 59.: The chapel was seriously damaged during second World War and also because of the fire in XIX century. Most of the stuccos appeared to be hollow and de-attached from the disintegrated plaster and brick wall. Stucco preservation including injections of silanes and grouting. Photographic documentation of the entire chapel form the inside.

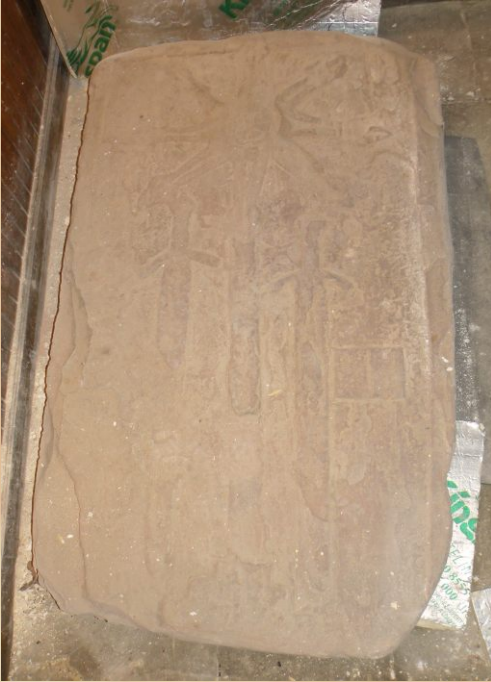
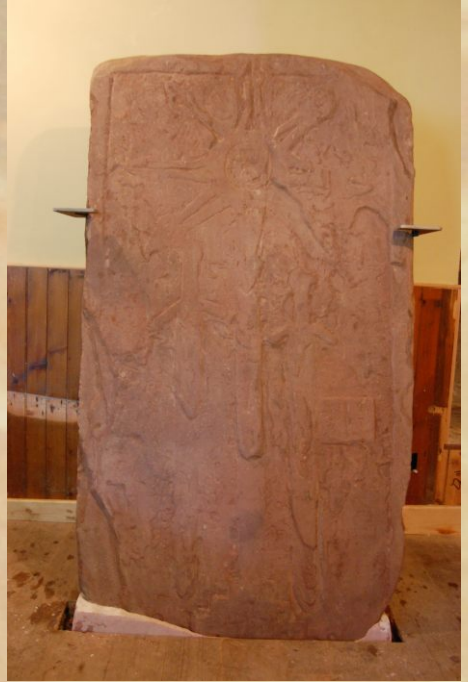
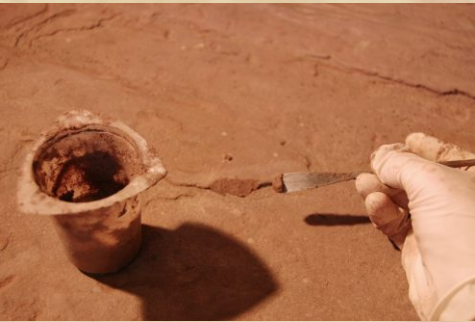
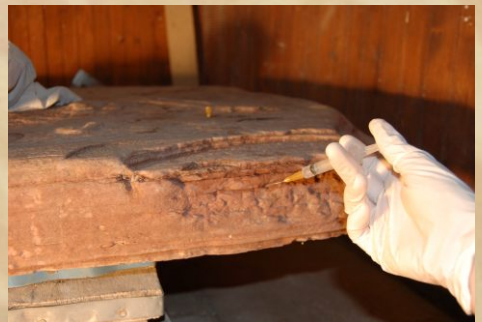
Fig. 60-63.: Conservation of XIV century Tombgrave including: steam cleaning, desalination, consolidation of delaminations using solutions of Paraloid B72 mixed with acetone and IMS (methanol), acrylic mortar repairs, Base making to provide firm and even support for the stone.

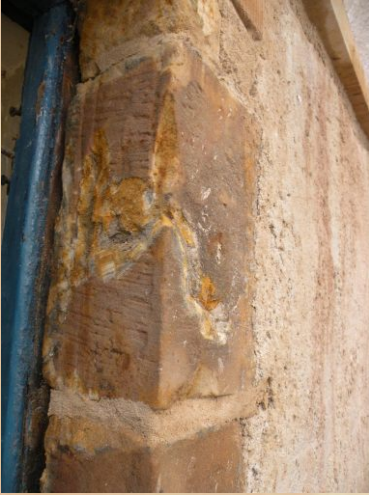
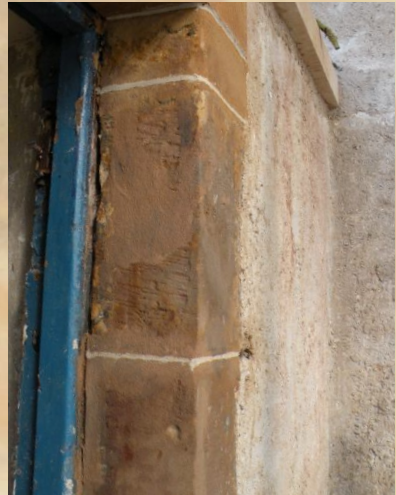
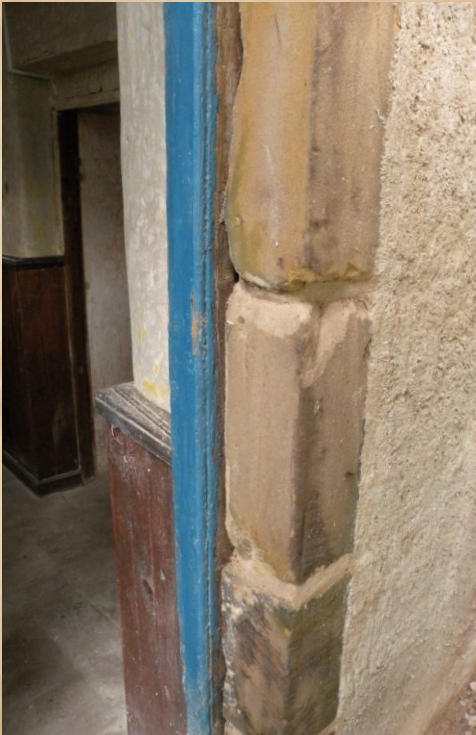
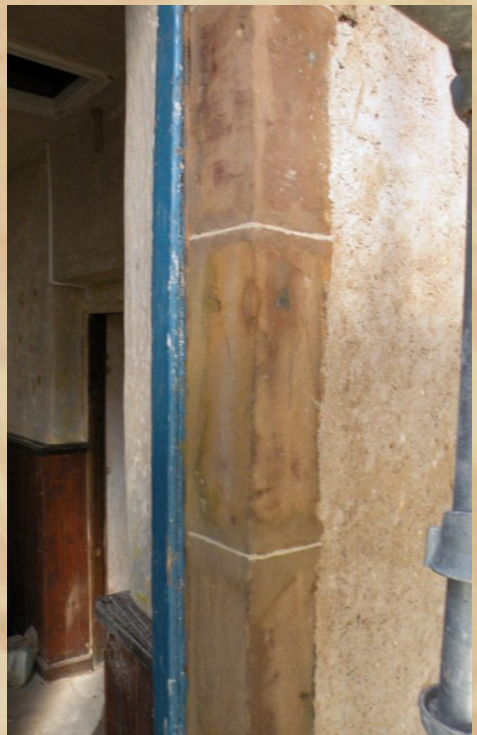
Fig. 64-67.: Lime mortar repairs on window and door surrounds.

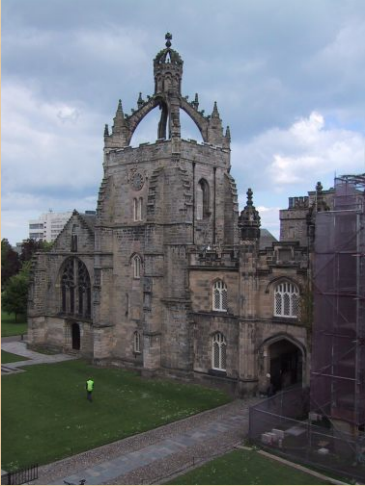
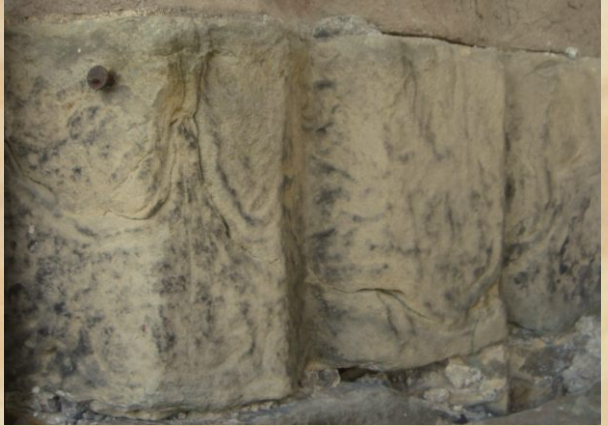
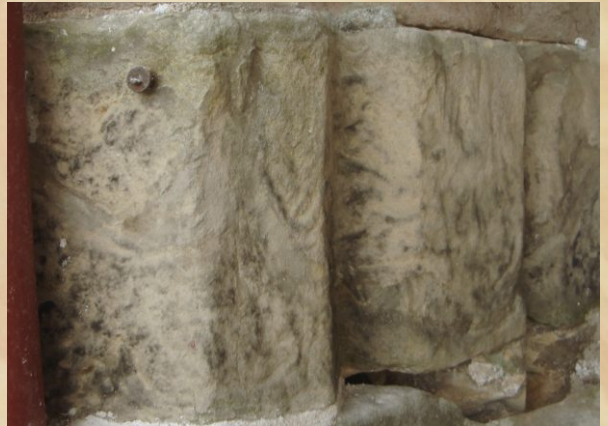
Fig. 68-72.: Responsible for lime mortar repairs on the Crown Tower of King's College . Leading a small group of conservators.

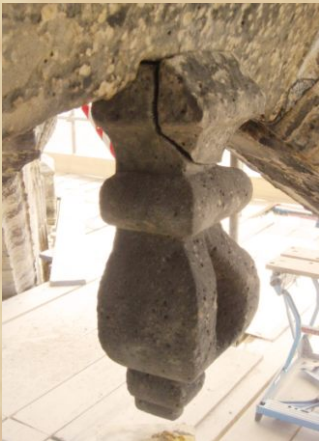
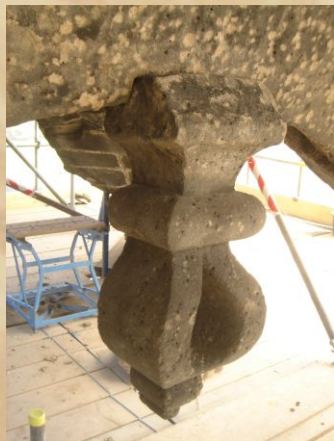
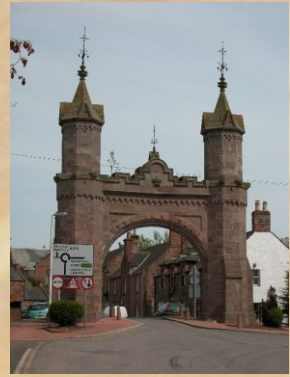
Fig. 73-75.: Fettercairn Arch:
Responsible for the lime mortar repairs
and stone consolidation.

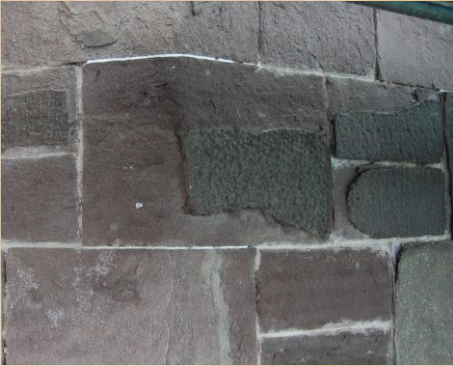
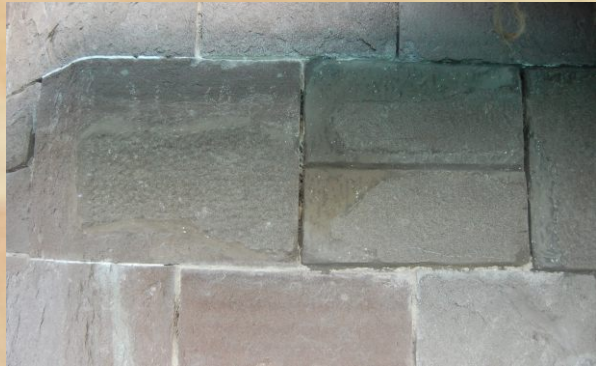
Fig. 76-77.: Dingwall Town Hall Balcony. Conservation of the main part. Report with recommendations how to proceed with each stone, Steam cleaning, removal of old resin repairs, consolidation of delaminations, acrylic mortar and lithomix repairs, inserting stainless steel armatures into delaminating stones.

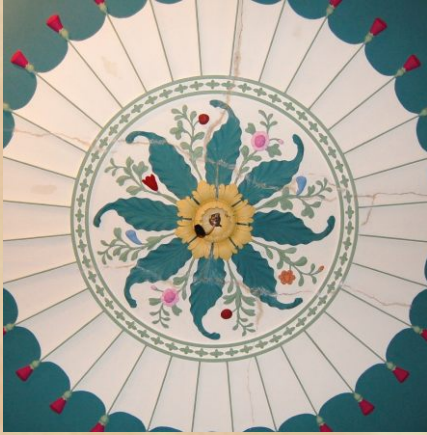
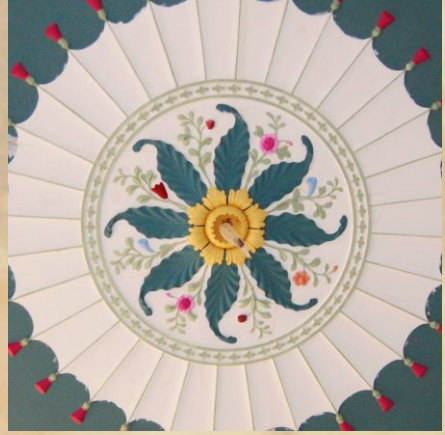
Fig.: 78,79.: Crack consolidation and re-painting of the damaged ceiling rosetta.

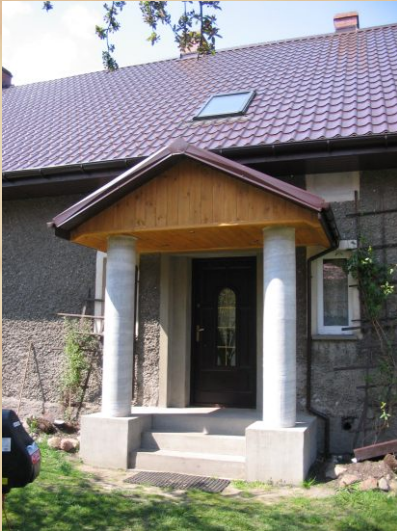
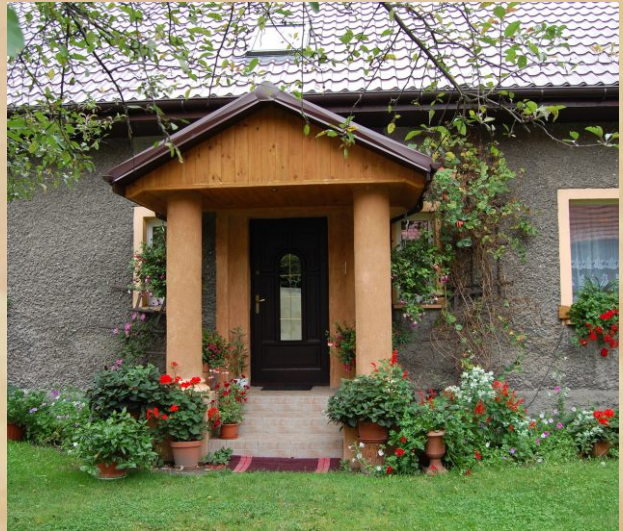
Fig. 80-82.: Lime and white Portland cement pigmented render imitating sandstone of warm colour.
